Pacific Inspection Group
Somewhere In Paradise 2
Keaau, Hawaii 96749

Somewhere In Paradise 2
Keaau, Hawaii 96749

Others Present Buyer Property Occupied Vacant
Inspection Date 11/04/2013
Start Time 10:15 AM End Time 12:30 PM
Electric On Yes
Gas/Oil On No
Water On No
Temperature 76
Weather Rain Soil Conditions Wet
Building Type Single family Garage Carport
Sewage Disposal Septic How Verified Visual Inspection
Water Source Catchment How Verified Visual Inspection

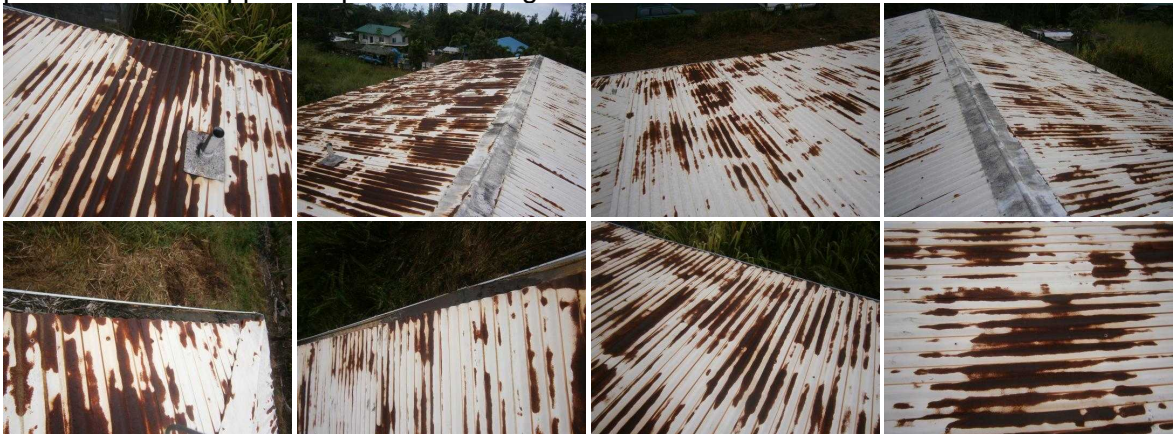
- 1. Method of Inspection: On roof
- 2. Defective Material: Metal Roof has heavy rust since this feeds the catchment tank it should be cleaned and painted with an approved paint for food grade use.

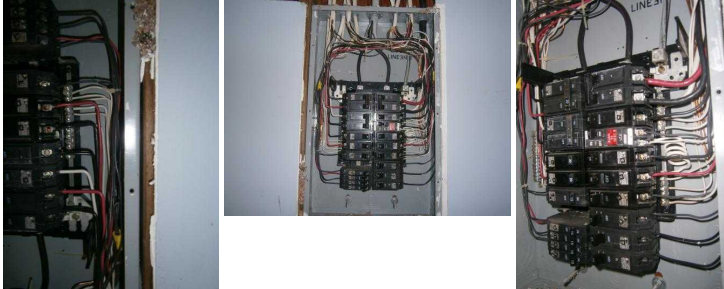
Garage Electric Panel

7. Acceptable Manufacturer: General Electric

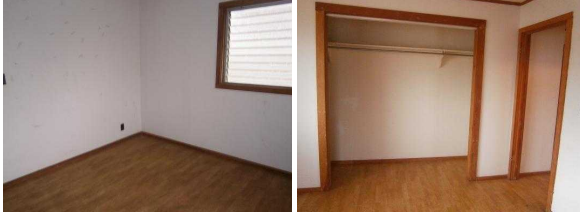
Bedroom Bedroom

- 10. Acceptable Floor: Laminate
- 11. Defective Windows: Louver Will not open-requires correction
- 12. Acceptable Electrical: 110 VAC

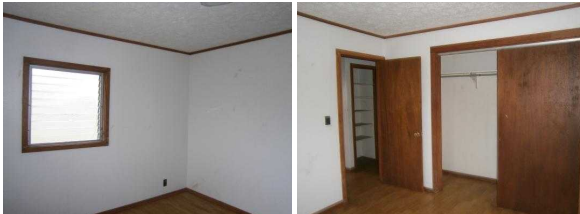
Bedroom # 2 Bedroom

- 16. Acceptable Floor: Laminate
- 17. Defective Windows: Louver Will not open-requires correction
- 18. Acceptable Electrical: 110 VAC

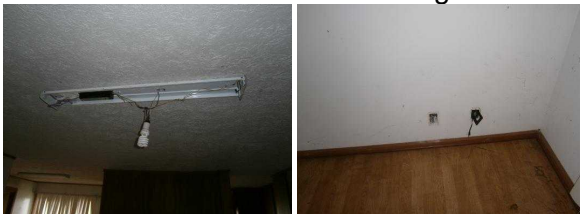
Family Room Living Space

- 1. Acceptable Ceiling: Paint
- 2. Acceptable Walls: Paint
- 3. Acceptable Floor: Laminate
- 4. Defective Doors: Solid wood The surface laminate is peeling
- 5. Marginal Windows: Louver Hard operation-needs improvements for ease of operation
- 6. Defective Electrical: 110 VAC Install missing outlet/switch cover plate(s)improper light bulb in fixture

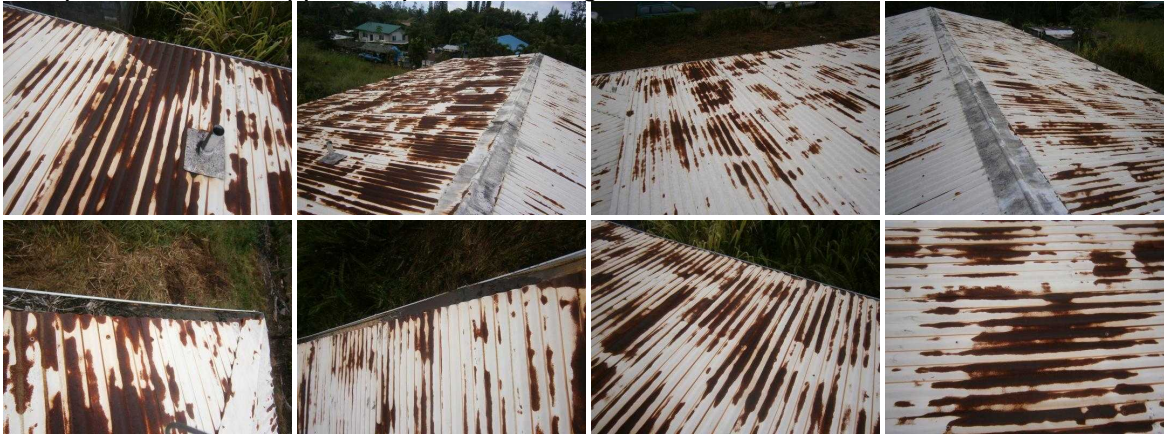
2. Main Roof Surface Material: Metal Roof has heavy rust since this feeds the catchment tank it should be cleaned and painted with an approved paint for food grade use.

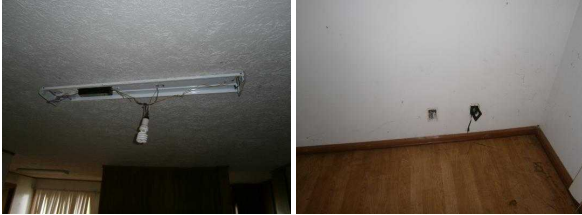
- 13. Family Room Living Space Doors: Solid wood The surface laminate is peeling
- 14. Family Room Living Space Electrical: 110 VAC Install missing outlet/switch cover plate(s)improper light bulb in fixture
